Open Water Access Assessment

GROUP: Services, Darlington Borough Council	SECTION: community safety team	Advising Safety Officer: andrew allison
Date Completed: 8/12/2021	Date Reviewed:	Name of Reviewer:
Weather conditions on day of assessment: Dry, cold and good daylight	Was river in flood or drought on the day of the inspection (consult colleagues on this if you are unfamiliar with area)?	Not applicable as these are all static reservoirs.

Risk Assessment (Summary)

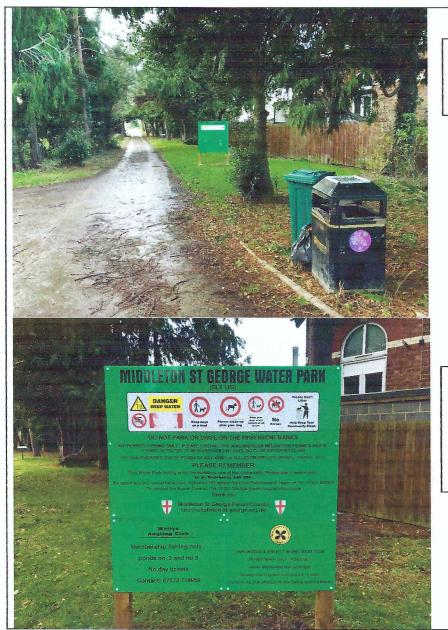
Entrance to the community centre parking and the reservoir area.

Signage at the entrance to the community centre parking and the reservoir area.

Note the sticker used to try and cover some of the wording.

Description of further controls	Segment Risk Rating Score with further controls (appendix 1)
Add an additional sign to the existing information signs. "In an emergency call 999 and ask for the Fire and Rescue Service"	27%
Your 'what3words' location is fools.aged.alcove	
Affix a sign to the wall on the left of the clubhouse door (as pictured).	-
NO SWIMMING (with accompanying pictogram)	
"In an emergency call 999 and ask for the Fire and Rescue Service"	
Your 'what3words' location is fools.aged.alcove	
Install a 20 metre throwline on the clubhouse wall adjacent to	
the levee. This should be secured using a combination padlock	
and affixed to an advisory sign (as pictured above).	
'Quote Location – Middleton St George Water Park'	
Inform County Durham and Darlington Fire and Rescue Service	
of the provision and padlock combination code.	
The code should also be known to the members of the model	
boat club in case they are required to use it, but they should

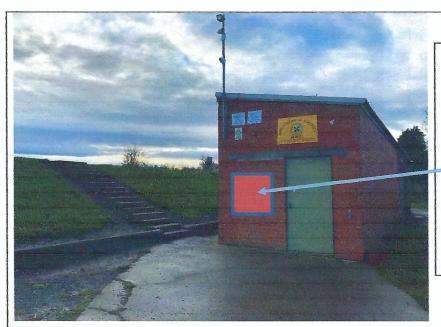
Model boat club – brick built clubhouse next to reservoir 1. This end wall faces the car park and main entry point.

Additional signage could be fixed here to reduce the chances of vandalism.

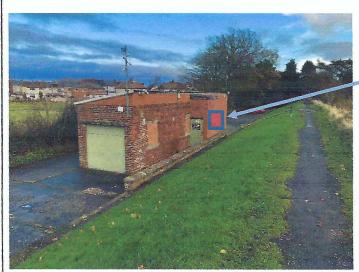
Well defined path leading past the clubhouse.

Warning signs, a padlocked throwline and information on how to report an incident could be affixed here. This would be covered by existing cctv.

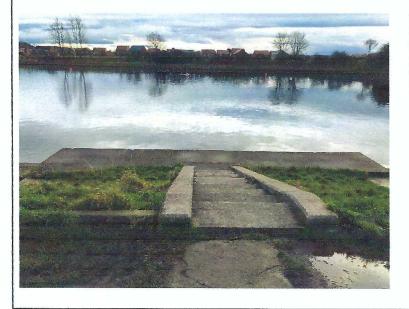
Steps down to the concrete observation platform used by the motor-boat club.

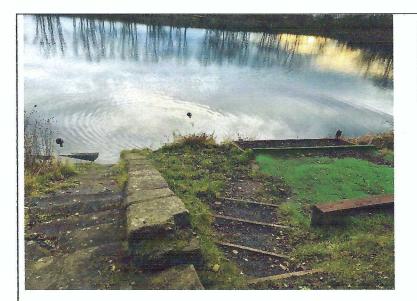
Example of the type of construction used for the fishing pegs around reservoir 3.

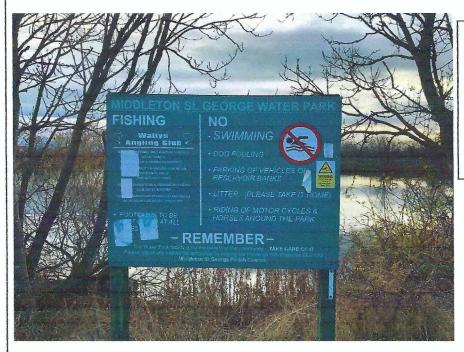
Example of the signs used around the reservoirs. Note the stickers used to try and cover some of the wording.

There is no guidance on how to report an incident, but it does give a geographical location.

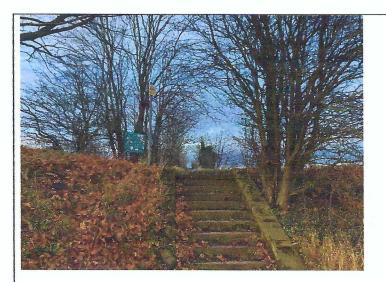
Deep water sign and warning / information signs used around the reservoirs.

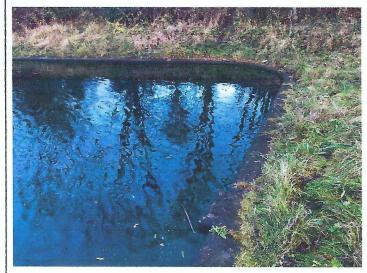
The concrete edging surrounding most of the reservoirs.

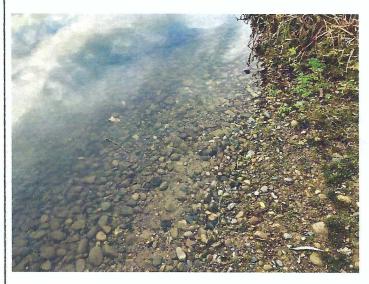
Shallow, sloped, pebbled edging found at some areas of the reservoirs.

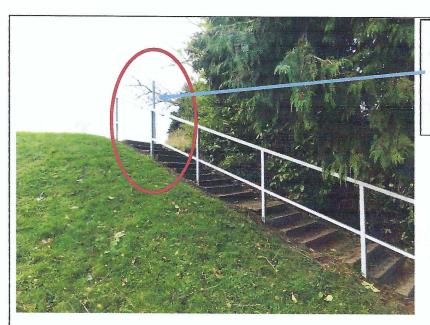
Steps leading from the rear of the community centre up onto the top of the levee. There is a post at the top of the steps but whatever sign was on it has been removed.

Affix a warning sign to the existing post at the top of the steps
leading from the community centre car park area.

'NO SWIMMING' + Deep Water, including corresponding
pictograms.

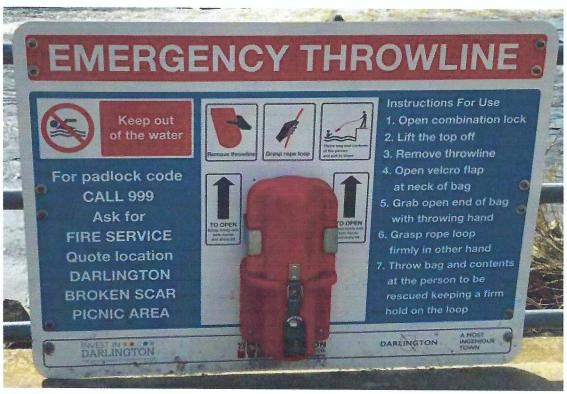
Suggested type of sign and throwline that could be affixed to clubhouse wall.
