Middleton St George Parish Council

MIDDLETON ST GEORGE RESERVOIRS
(otherwise known as the Fighting Cocks Reservoirs)

**REPORT ON AN INSPECTION UNDER SECTION 8 OF THE
RESERVOIRS ACT 1975**

March 2023

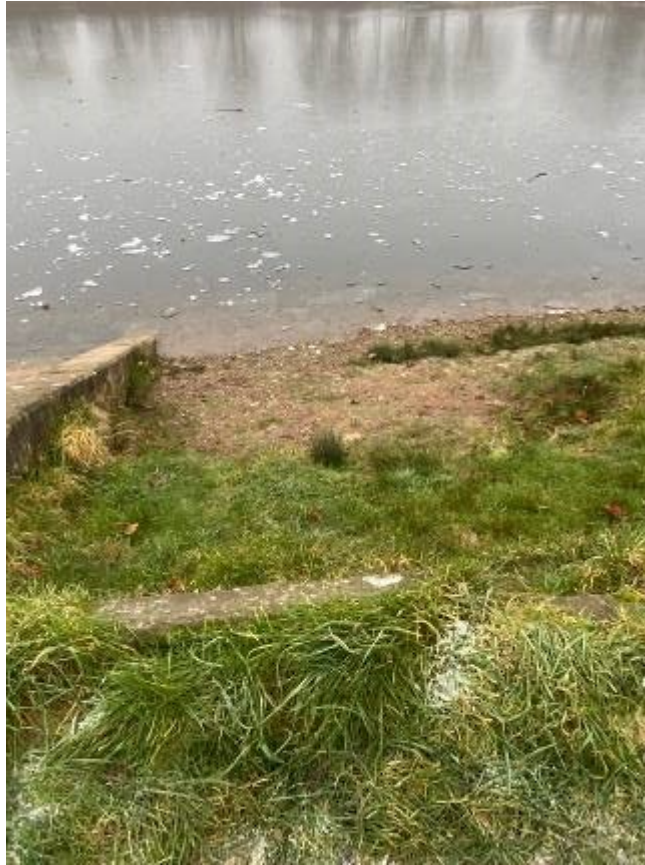
Damage to upstream face

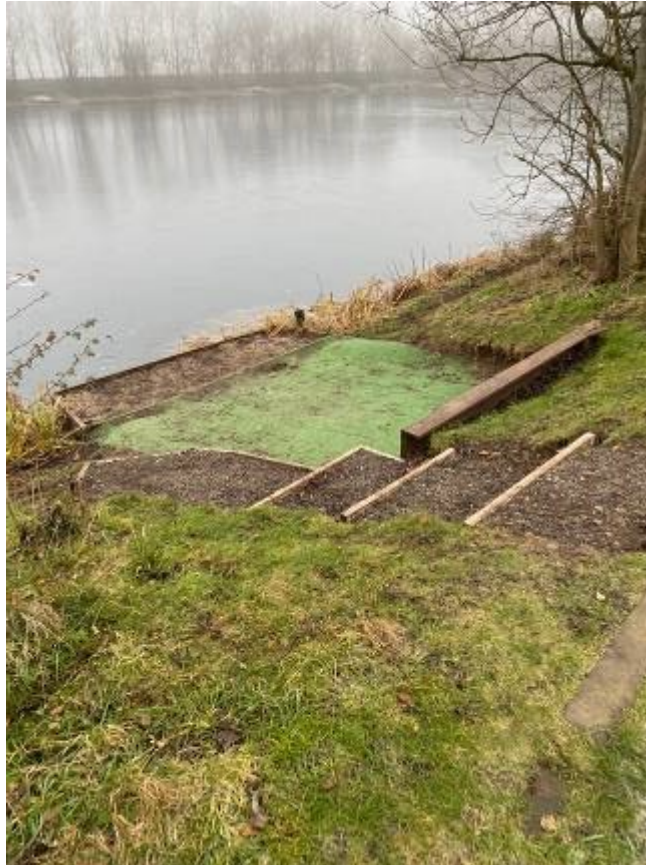
It appears the fishing club on the reservoir has formed substantial fishing platforms which have cut deeply into the upstream face of the dam. This has severely weakened the dam, and so **I recommend the fishing platforms be refilled where they have been cut into the embankment.** This has been recommended before but not actioned.

Fishing platform

- (iii) the fishing platforms on Reservoir No. 3 be refilled where they have been cut into the embankment – **I recommend these works are carried out within 12 months of the date of this report.**

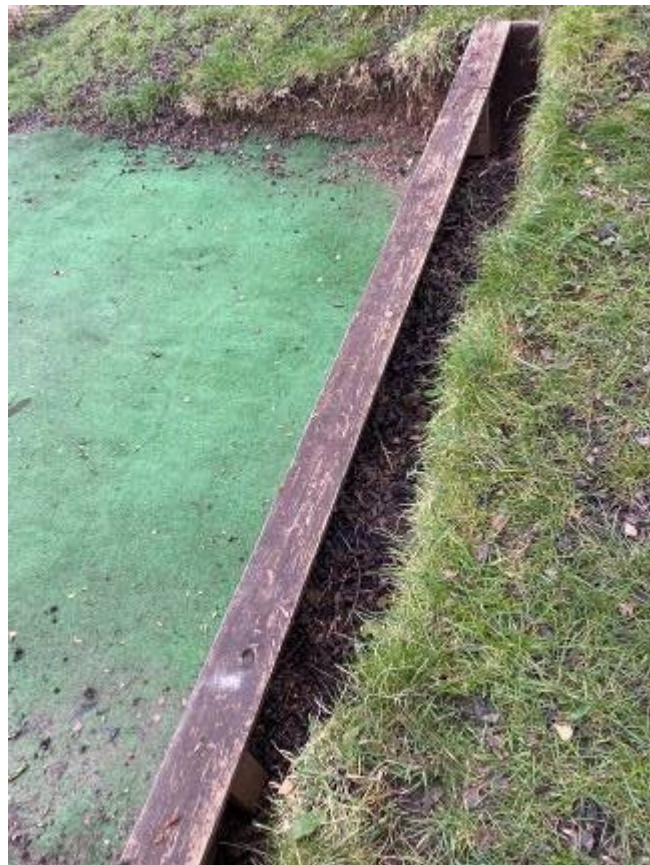
Damage behind fishing area

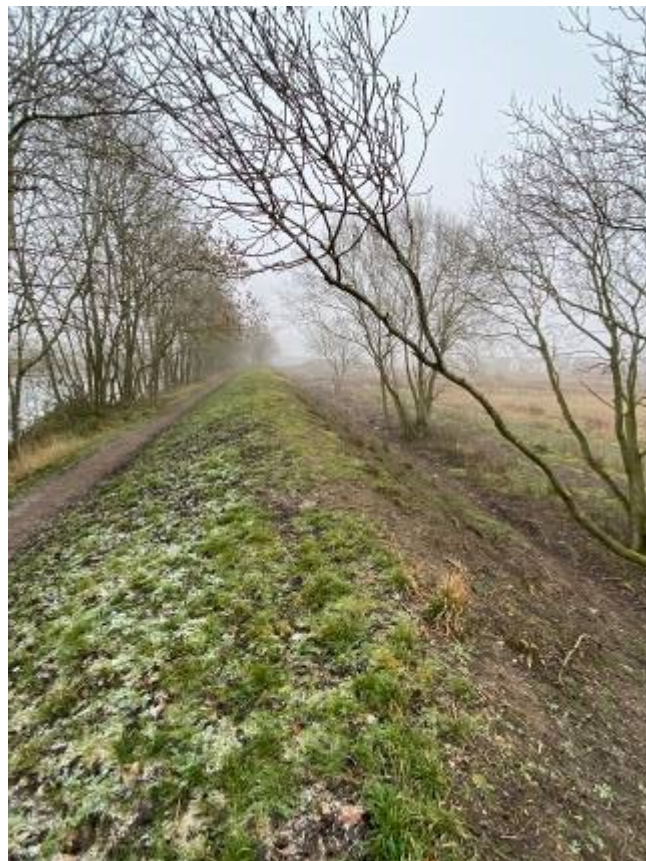
Clearance of downstream face

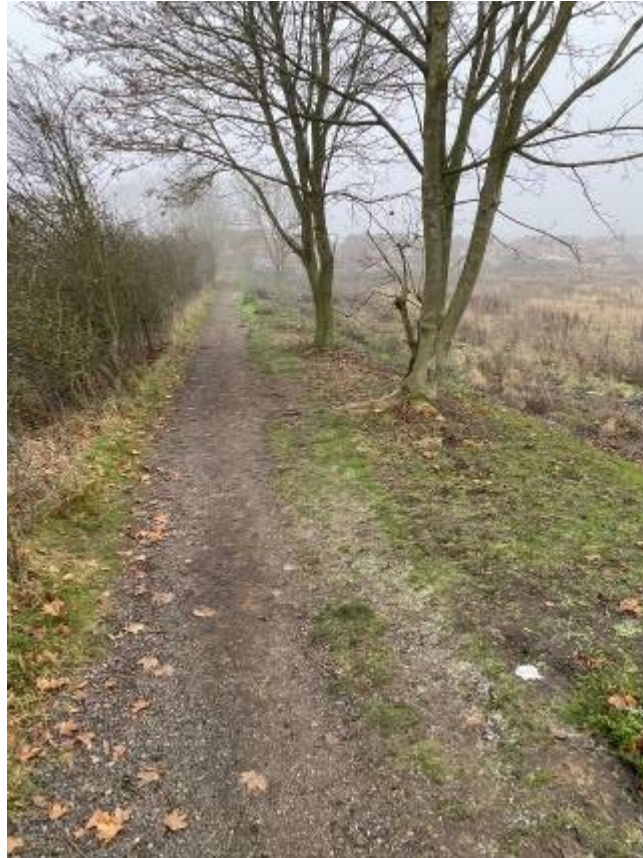
Crest and cleared downstream
